Cowles Dissolver Fire Involving IR Flare Mix

Dr. D.R. Dillehay and R.C. Leander

Thiokol Corporation

Abstract

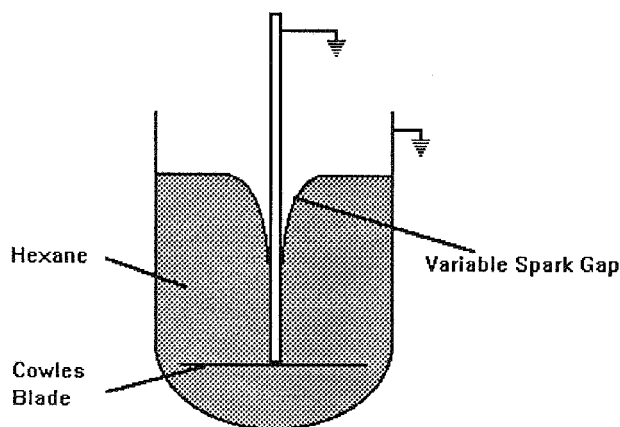
There are several grounded discharge paths for the charge to follow for dissipation, however, the solvent is only "static dissipative", not conductive. During the mix cycle, the swirling of the particles in the hexane may cause a buildup of charge in the liquid. This charge will continually try to bleed off, but may vary in intensity as a function of speed of mix blade, absolute humidity of the air, ground integrity, etc. If the charge exceeds the breakdown potential for air (25,000 volts/cm), a discharge may occur. The vortex created by the mixer blade/shaft provides a ready path for the discharge to occur to the grounded shaft. The figure below shows this graphically.

In this case, the "semi-conductive" nature of the hexane may allow buildup of a considerable charge in the bulk of the liquid since only a small portion of the hexane actually contacts a grounded path for dissipation. Under the right circumstances, a discharge could occur between the liquid and the grounded shaft. The ignition energy for a flammable concentration of hexane and air is 0.29 millijoules (0.00029 joules). If the concentration of hexane is between 1.25% and 6.90% by volume in air (Lange's Handbook of Chemistry, Ninth Edition), ignition of the hexane vapor will occur from a very small spark. The flash point of hexane is - 7 °F. As shown previously, the sweeping of the hexane flame down into the bulk of the slurry will cause ignition of the entire mixture. The pressure from the burning mixture throws

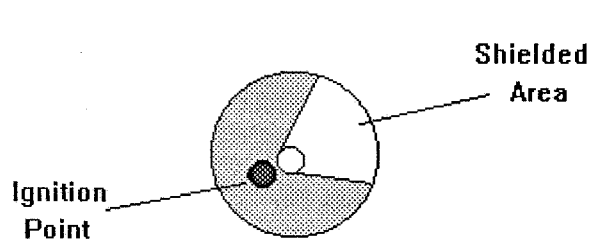
From the tape, the ignition occurring on the front side of the bowl would have allowed the shaft to shield the back side of the bowl from the pressure wave and generated an unbalanced force on the mix. This unbalanced force would have forced the mix down and out the back of the bowl and into the back side of the bay. Examination of the heavy ash deposits in the back of Bay R-110 suggests that this did occur. In this scenario, the hexane ignition alone would have been sufficient to blow the panels off the outside wall and the mix would have ignited as the hexane vapors were driven off of the mix as it splattered throughout the back of the bay. The main fireball from the flare composition would have been reduced somewhat by the action of the deluge water absorbing some of the heat. The video tape frames after the ignition also support continued burning within the bay for a significant time after the main fireball from the mixer bowl.

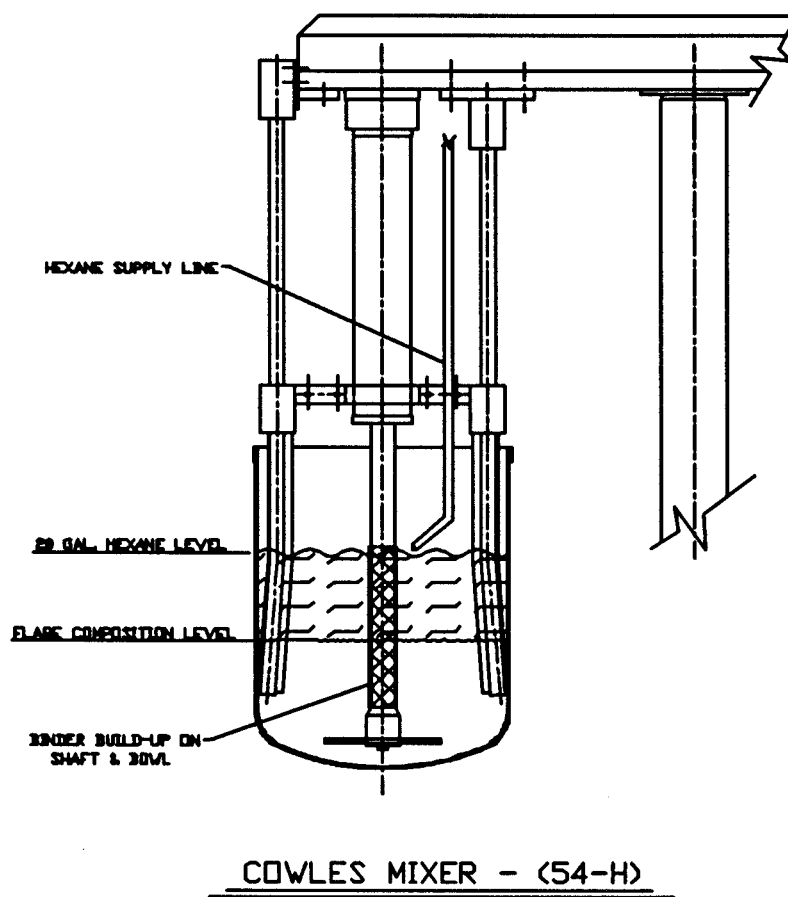
Figure 3. Details of the Cowles Dissolver Configuration

It was observed that there is a layer of charred material on the mixer shaft. This layer is in the region where the hexane pours onto the shaft. It was measured at 22 inches above the bottom of the shaft. The mixer bowl measures approximately 34 inches from the center to the top. The bottom of the shaft is estimated at 2 inches above the bottom of the bowl which means that the top of the layer is estimated at 10 inches below the top of the bowl. It was observed, also, that there is char on the mixer bowl walls that could be related to this binder coating the bowl walls. The area directly under the mixer blade appears to be relatively free of char. When the acetone/binder solution is shocked by the hexane, some of the binder will precipitate on the shaft. Likewise, some of the binder will precipitate on the walls of the mixer bowl. These layers may serve to insulate the shaft and the bowl and reduce the grounding potential of these surfaces. This would aggravate the build-up of electrical charge by reducing the grounding paths to drain the charge. By the time the hexane is added to the mixer bowl, the ground path could be less effective. The area of the mixer shaft above the mix would be uncoated, however, and could serve as a ground point for the electrostatic charge to discharge through. As the last of the hexane enters the bowl, the top of the solvent layer is observed to be about the right level to allow a discharge from the surface of the solvent to the uncoated mixer shaft. This scenario fits the observed ignition on the video tape and the overall pattern for an ESD event to ignite the hexane vapors. Figure 3. shows the position of the pipes, mixer blade and bowl with indicators marked for binder deposits.
